# Manhole Inspection Summary

Manhole # S05QQ1001MH

Insp Date: **6/27/08 10:51 AM**

**Location** Address: **5402 PARK HEIGHTS AVE**

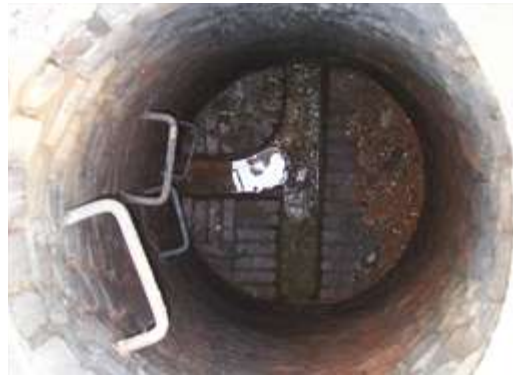
Top View

DEBRIS ON BENCH AND CHANNEL

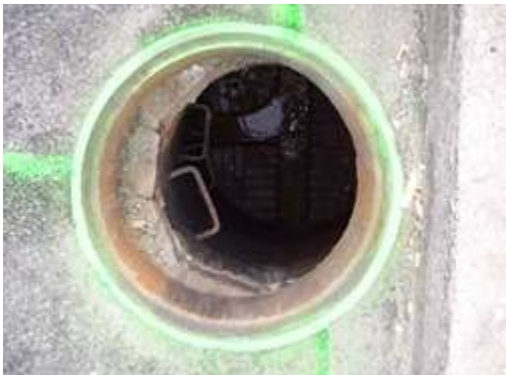
Defect 1

Condition: ☐ Sound ☐ Cracked ☐ Root Intrusion ☒ **Loose Brick** ☐ Deteriorated

LOOSE BRICK ON FRAME  
ADJUSTMENT AND OFFSET OF  
CHANNEL AND FRAME

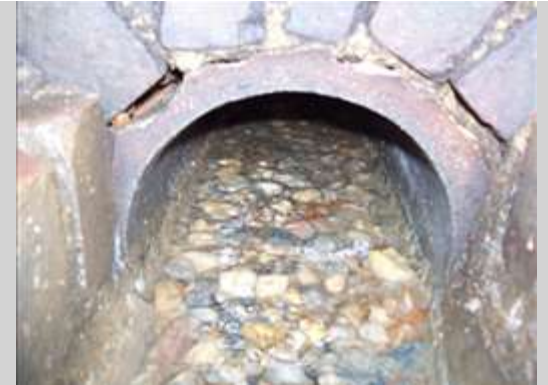
12 O'Clock Outflow

8 in. Circular Gravity Sewer  
Pipe Out @ 12 O'Clock

Pipe Height: (in.) Direct  
Pipe Material: **Clay** ☐ Pipe Lined  
Invert Depth: **8.99** (ft.) Flow Characteristics: **Slow**  
Deposits: ☐ None ☐ Mud ☐ Sludge ☒ **Debris** ☐ Grease  
Silt Depth: **2** (in.) Deposits Extent: **Medium**  
Infiltration: **None** Pipe Seal Cond: **Cracked**

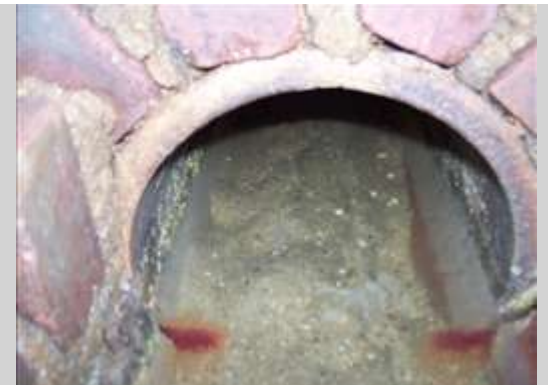
6 O'Clock Inflow

8 in. Circular Gravity Sewer  
Pipe In @ 6 O'Clock

Pipe Height: (in.) Direct  
Pipe Material: **Clay** ☐ Pipe Lined  
Invert Depth: **8.95** (ft.) Flow Characteristics: **Slow**  
Deposits: ☐ None ☐ Mud ☐ Sludge ☒ **Debris** ☐ Grease  
Silt Depth: **1** (in.) Deposits Extent: **Light**  
Infiltration: **None** Pipe Seal Cond: **Sound**

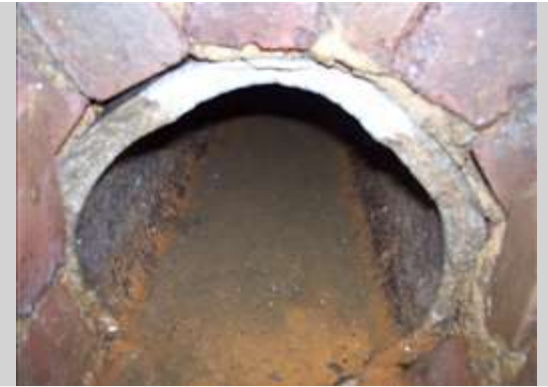
9 O'Clock Inflow

Deposits: ☐ None ☐ Mud ☐ Sludge ☒ **Debris** ☐ Grease

Silt Depth: **1** (in.) Deposits Extent: **Light**

Infiltration: **None** Pipe Seal Cond: **Cracked**
